FLOOD INSURANCE STUDY

**VILLAGE OF
SOUTH DAYTON,
NEW YORK
CATTARAUGUS COUNTY**

JULY 1977

**U.S. DEPARTMENT of HOUSING & URBAN DEVELOPMENT
FEDERAL INSURANCE ADMINISTRATION**

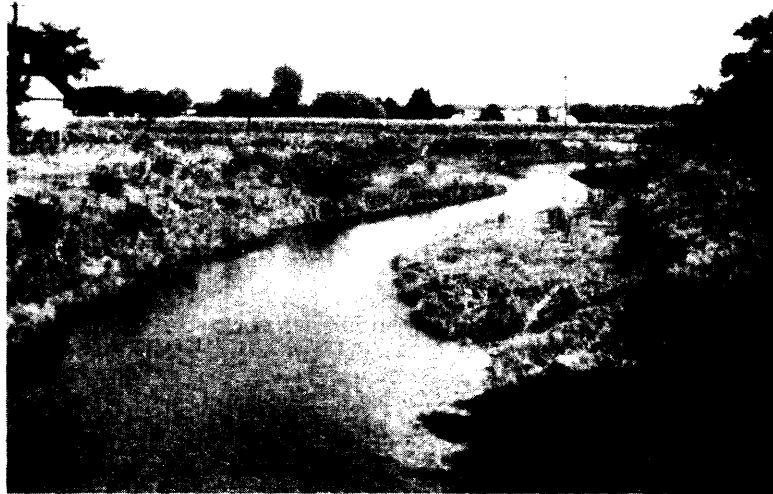
Figure 2 - West Branch of Conewango Creek at Mile Strip Road looking south (downstream).

Portions of the flood plain along the West Branch Conewango Creek are illustrated in Figures 2 and 3.
